*Accident
on 5 November 2000
at Paris Charles de Gaulle (95)
to the Boeing 747-200
registered TJ-CAB
operated by Cameroon Airlines*

REPORT
tj-b001105

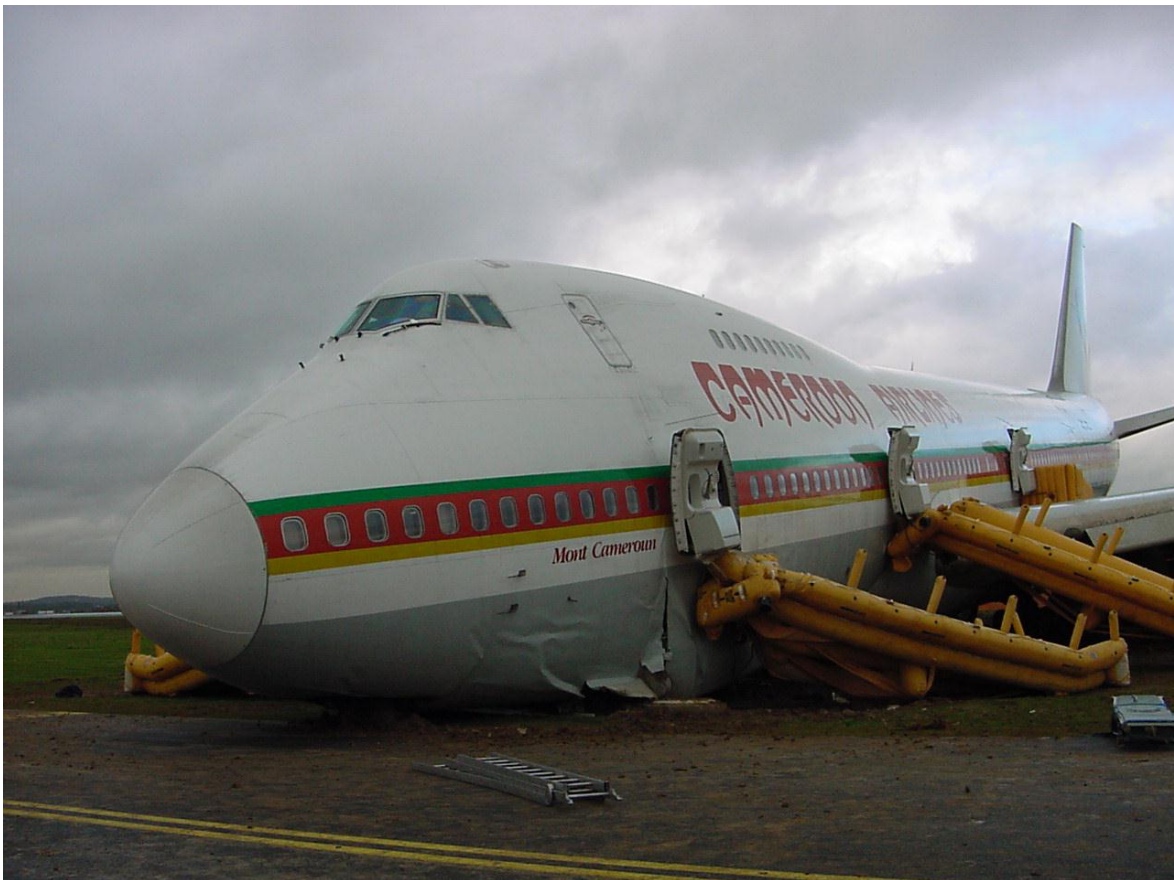
The structure of the airframe was severely damaged at the level of the electronics bay; it was impossible for the aircraft to be returned to service.

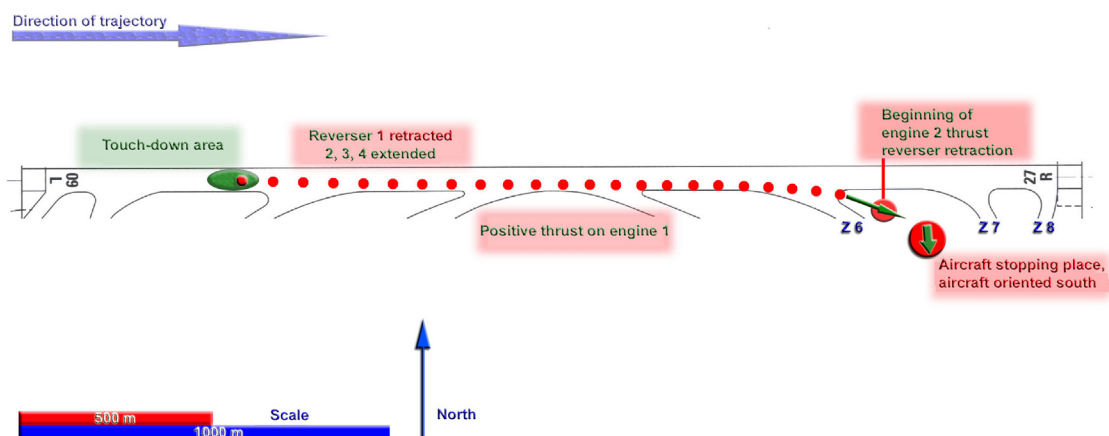
Aircraft trajectory on landing roll:

The points correspond to the aircraft's trajectory sampled every second. The spacing between the points indicates a lack of deceleration.

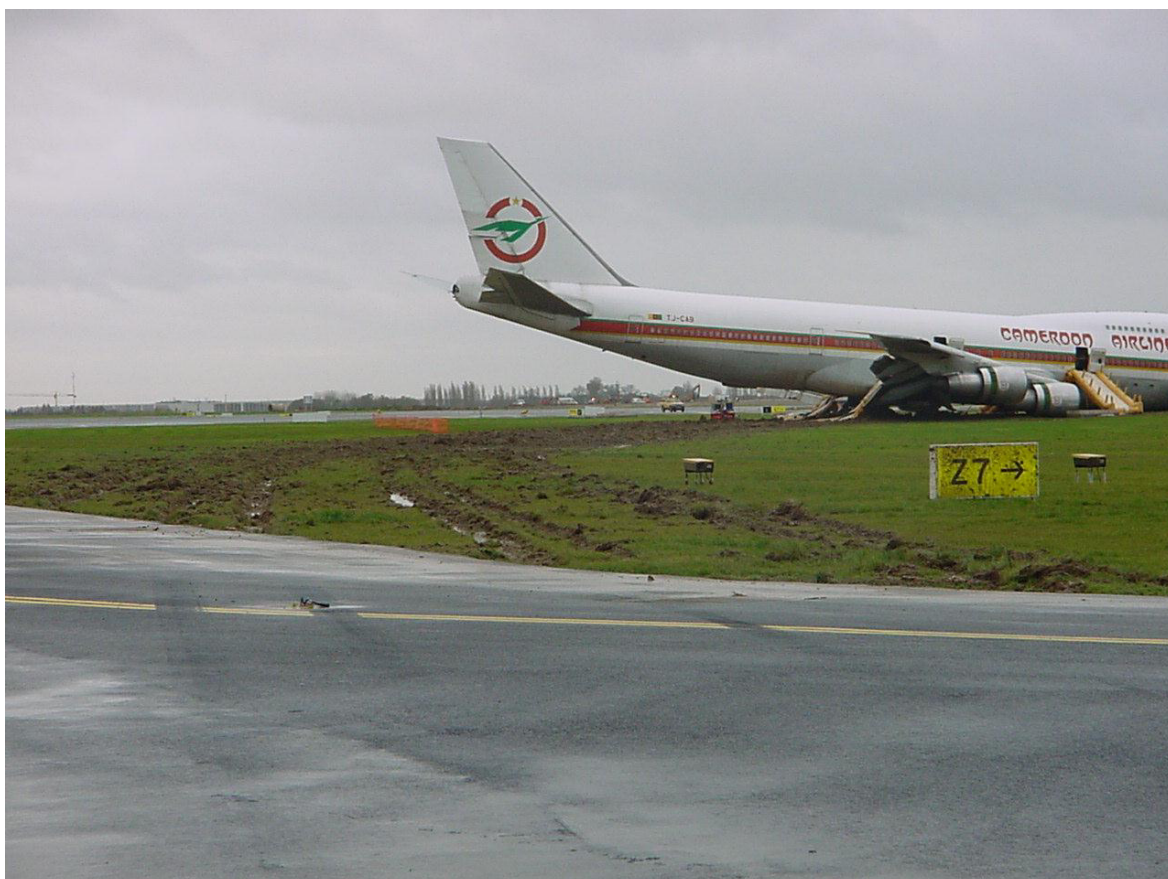
On impact with the concrete structure of the rainwater collector tank, the nose gear, bent backwards, penetrated the airframe at the level of the electronics bay, causing extensive damage to the equipment contained therein.

None of the four engines showed any visible signs of damage.

Three emergency slides were deployed on each side of the aircraft.

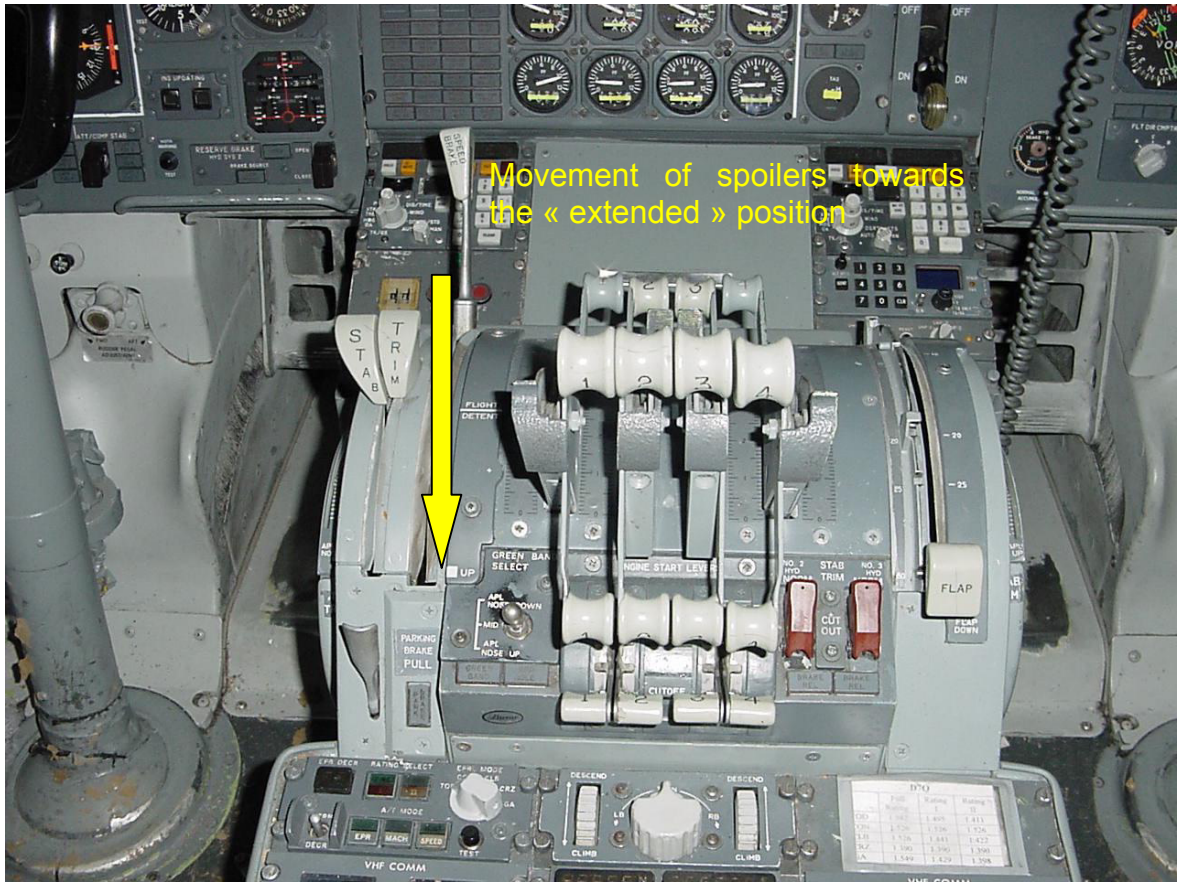
The four thrust levers were found in the idle position. It was noted that the crew had fired the fire extinguishers and the APU. The electric switch for extension of the number 3 slats was found in the "Extend" position.

Note: the position of the buttons and levers in the cockpit should be taken with care, since the implementation of the "Passenger evacuation" check list was carried out at night.

The reasons for the increased thrust on engine 1 remain difficult to explain. It is not impossible that while reaching over to extend the spoilers, which are on the centre console next to the thrust controls (see photo in 1.12.3), the Flight Engineer may inadvertently have moved the n°1 thrust lever towards full positive thrust. A lack of coordination between the Captain and Flight Engineer, as well as an absence of joint control with the co-pilot, may have contributed to the failure to correct the situation.
